Project Case Study: Paddington Town Hall – Remedial Repairs & Restoration, Roof Upgrade, Mechanical Upgrade & Clock Tower Works

CLIENT: City of Sydney Council

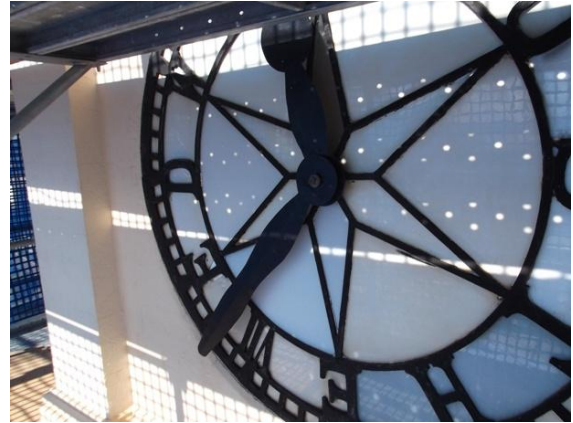
METHOD

Scaffolding the Town Hall and Clock Tower

The desalination, rendering and painting works required safe access. The adjacent pavements and public building access ways required protection from the work happening overhead. A Class B hoarding was used to protect the pavements and allow the Town Hall entrances to remain unobstructed. Scaffolding was erected around Oxford St and Oatley Road to allow access to the walls of the building and to the clock tower.

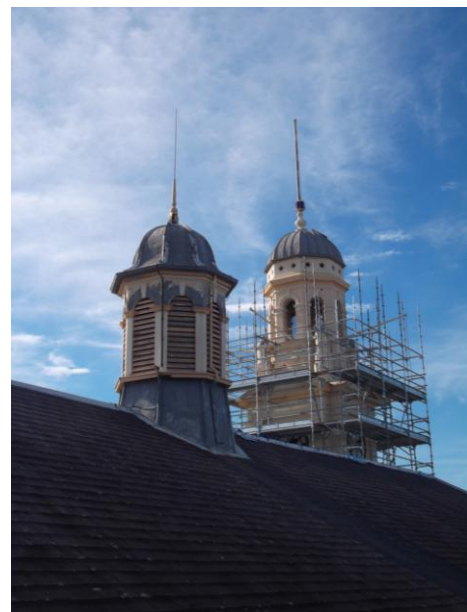
Air conditioning and Mechanical Works

5 new Mechanical units were installed to the rooftop of Paddington Town hall with the new units being mounted onto a new structural steel platform. The new and old units were lifted from Victoria barracks, Murphy's had to install temporary air to still service the active building. New AC duct was also installed to the roof top of Paddington Town Hall.

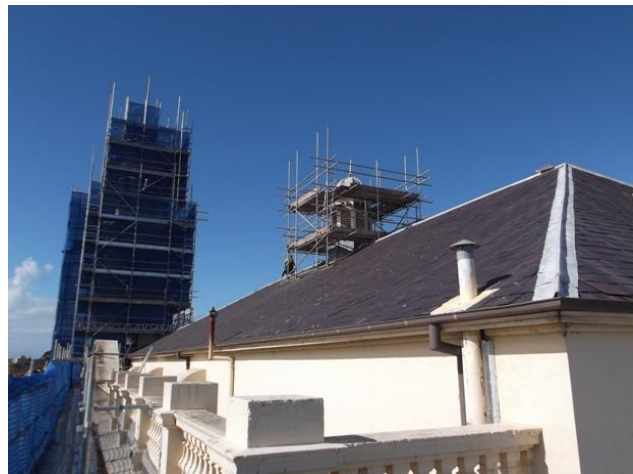
Crane Lifts

Lifting work in the project was safely performed by 80T cranes working from Oatley Road and Victoria Barracks depending where materials were needed. For these lifts Murphy's employed qualified traffic controllers to assist with pedestrian and traffic flow to the area. In one case due to the size of the lift Murphy's opted to perform the crane lift at night time to ensure as least disruption as possible.

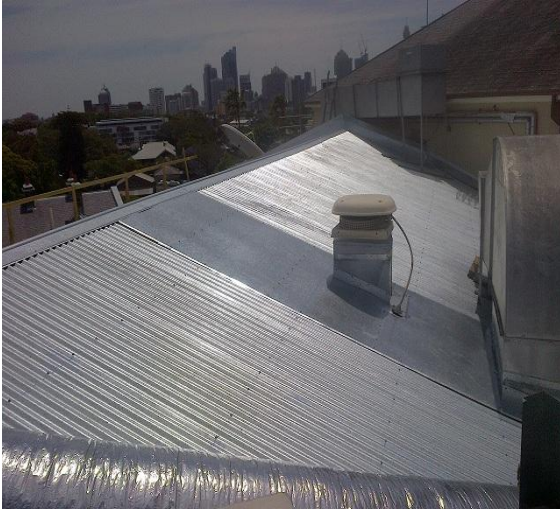
Metal Re-roofing

Metal roofs to cinemas one and two and office/caretakers roofs were restored using Colorbond steel roof sheets, flashings and cappings. One of the major constraints to re-roofing the Paddington Town Hall was the operational status of the working cinemas. Murphys worked around this issue by having an allocation of 2 hrs a day to re-roof the cinemas, other times were arranged to re-roof the cinemas, with consultation of cinema management and Councils Project Manager.

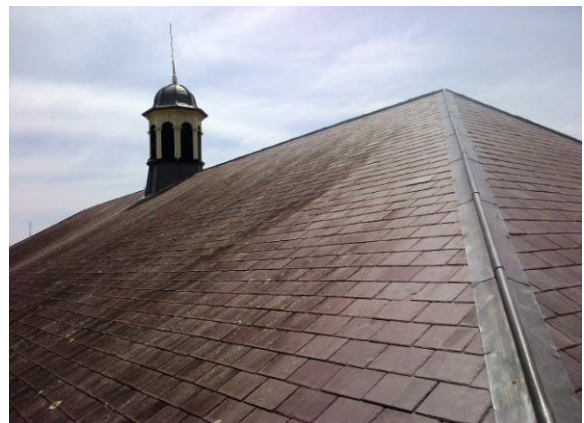
Replacement of selected slates of the roof to Stapleton Hall was carried out by trade qualified slaters with heritage building experience. Heritage lead workers installed lead flashings to the roof of hall to keep the heritage look of the slate roof. Lead works was also installed to the clock tower and pediments on Oatley St & Oxford St.
